LDPE Reactor mixer bearing faults – Part 1

LDPE REACTOR MIXER BEARING FAULTS

CASE STUDY

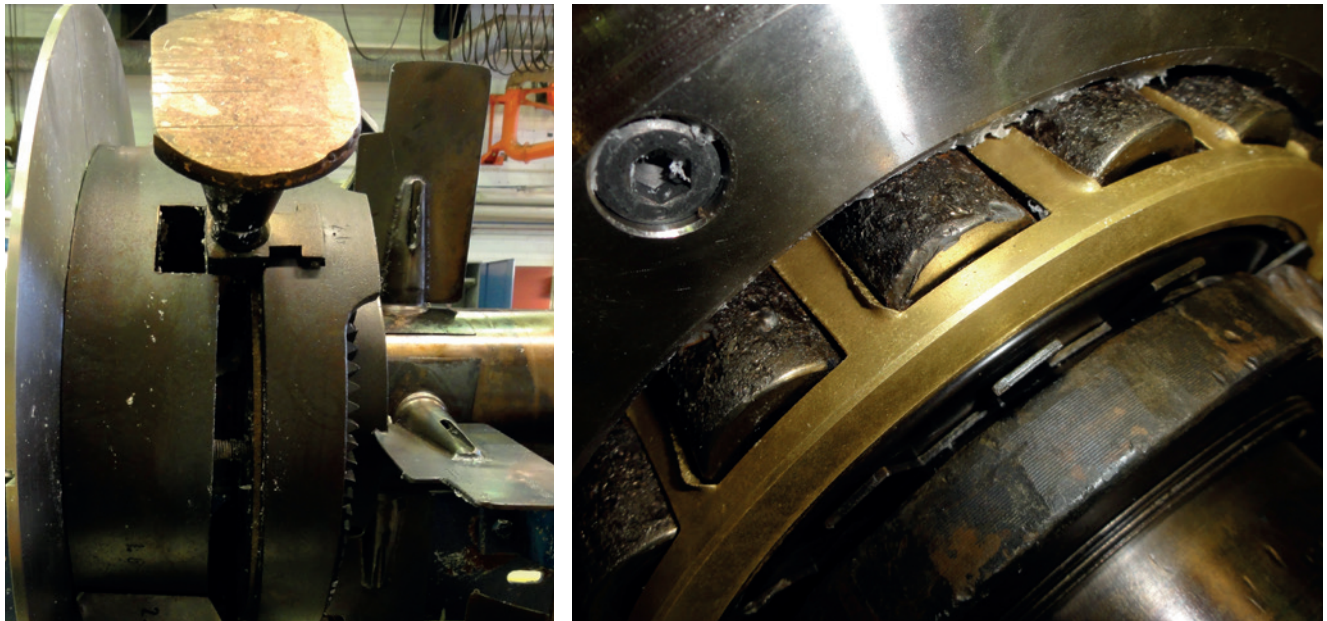
Figure 2. View of the damaged middle bearing of the reactor mixer, showing the fractured bearing housing (left) and the bearing rolling elements (right). The detection and diagnosis of this bearing fault is described in Part 2 of this article series.

Figure 10. Condition of the middle bearing when the reactor mixer was disassembled after shutdown. Damaged bearing (right) caused by polymer that entered the damaged bearing housing and hardened. The fractured bearing housing is shown on the left.

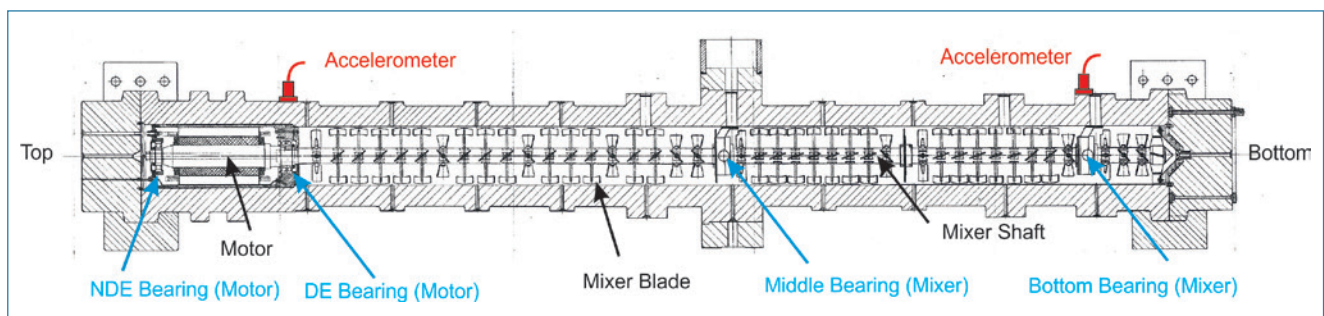
One of the primary machines in the LDPE production plant is the autoclave reactor; the focus of this case story. It is a 6.5m long, 530mm diameter pressure vessel with a self-contained motor, which drives a long shaft with many mixer blades mounted on it (see Figure 3). The mixer portion of the reactor stirs the ethylene and peroxide mixture at high pressure to initiate and control the polymerization process (see a description of the LDPE

Figure 3. Autoclave reactor core showing location of the ATEX certified accelerometers and the bearings which are monitored by these accelerometers. The mixer shaft bearings are identical. (The reactor is shown on its side in this picture, normally it stands upright.)

As shown in Figures 3 and 5, the four rolling element bearings in the reactor are monitored by two accelerometers. The primary fault detection measurement used is a bandpass acceleration measurement. The setting for signal response is nearly the same as that for a RMS and peak-peak measurement settings. The frequency range of 1-5 kHz captures the rolling element bearing resonance frequencies, providing accurate, early indication of a developing bearing fault.

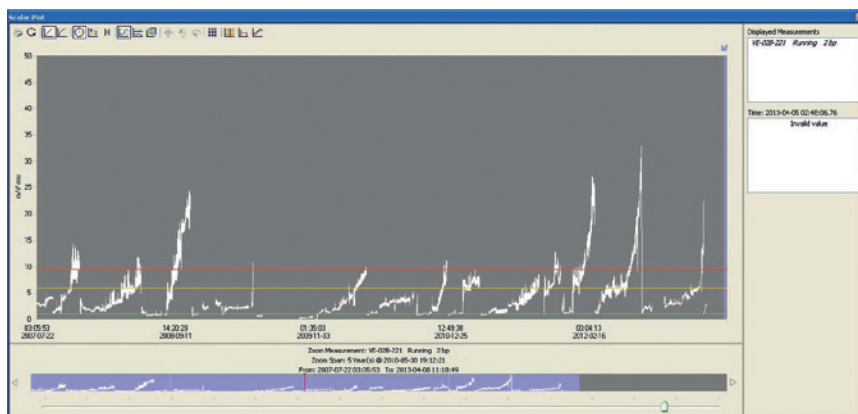
that fails the most often. As seen in Figure 1, some of the bearings have a relatively short life cycle; there were 11 shutdowns to replace damaged/worn bearings during a five year period.

Figure 1. Bearing vibration trend over a 5 years period showing primarily the DE motor bearing. (Acceleration band-pass measurement).

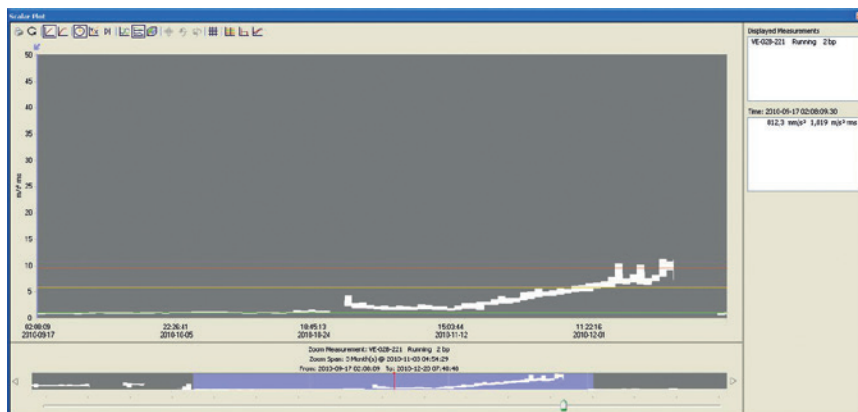
Figure 2. An example of a DE motor bearing fault trend. (Acceleration band-pass measurement).

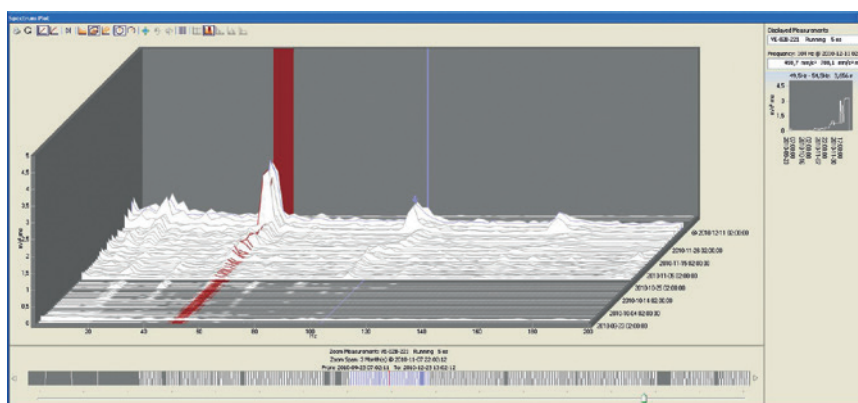
Figure 3. Ball bearing fault frequency trend (49.5-54.5 Hz) over a period of five weeks. Mixer was changed afterwards. (Envelope spectrum for acceleration).

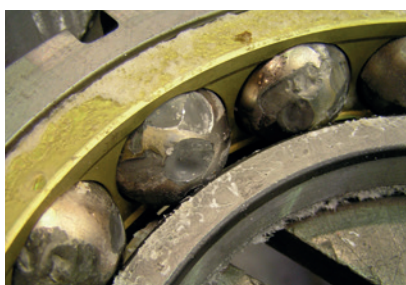
Figure 4. Condition of damaged DE motor bearings when reactor was disassembled after shutdown. Although the damage looks quite severe, only one set of the bearings was affected.

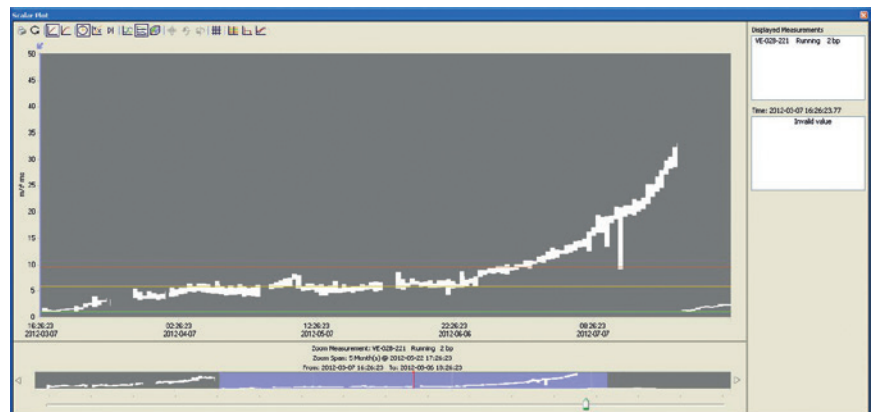
bearing fault is carefully monitored to ensure that the risk of bearing failure is still minimal until, for example, the next scheduled shutdown. Five examples of this can be seen in Figure 6, where

Figure 6. Multiple bearing faults seen over broadband frequency trend over a period of five months. Mixer was changed afterwards. (Envelope spectrum for acceleration).

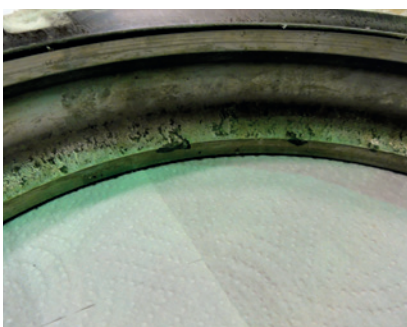
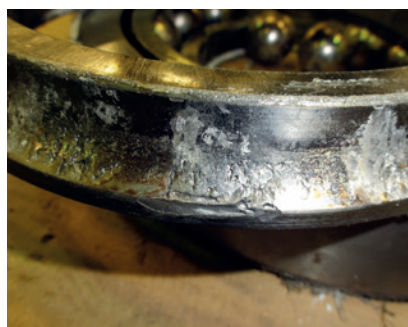
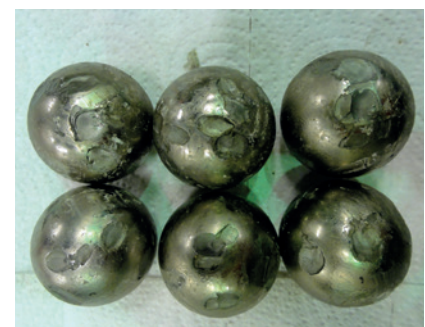
Figure 7. Condition of damaged DE motor bearings when reactor was disassembled after shutdown. Left: Outer race. Middle: Inner race. Right: Rolling elements. Both sets of the DE motor bearings were equally affected in this case (only one set shown), which is a much more severe situation than that shown in Case 1 (Figure 4).

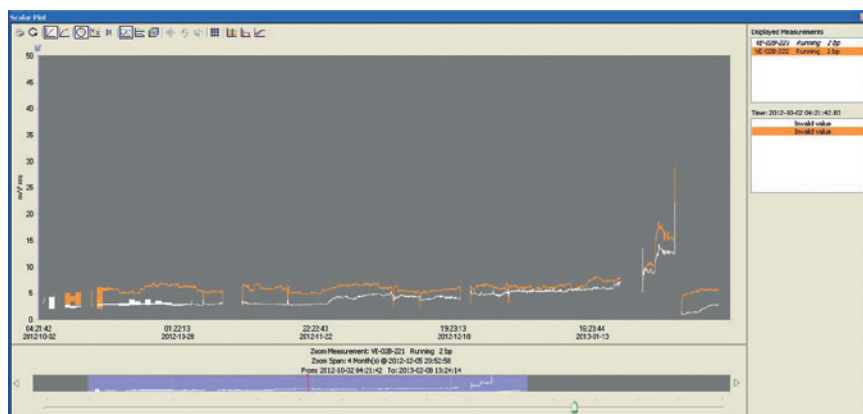
In this particular case, when the process was started up again, higher than normal vibrations were observed. In the course of just a few days the vibration amplitude doubled, as indicated

in Figure 8. The mixer was changed the next day. Upon disassembly, it was seen that hardened polymer had found its way into the bearing and caused the bearing to fail prematurely.

Figure 8. Orange: Lower accelerometer measurement trend for the mixer shaft bearings. White: Upper accelerometer measurement trend for the motor bearings. The trend is normal up to the process shutdown but immediately after the reactor was put back into service, the vibration increased. Although the damage was limited to the middle mixer shaft bearing, this influenced the vibration on the upper accelerometer. (Acceleration bandpass measurement.).
